NASA CR-135448
PWA-5512-21

PERFORMANCE DETERIORATION
BASED ON EXISTING (HISTORICAL) DATA
JT9D JET ENGINE DIAGNOSTICS PROGRAM

UNITED TECHNOLOGIES CORPORATION
Pratt & Whitney Aircraft Group
Commercial Products Division

Prepared for
NATIONAL AERONAUTICS AND SPACE ADMINISTRATION

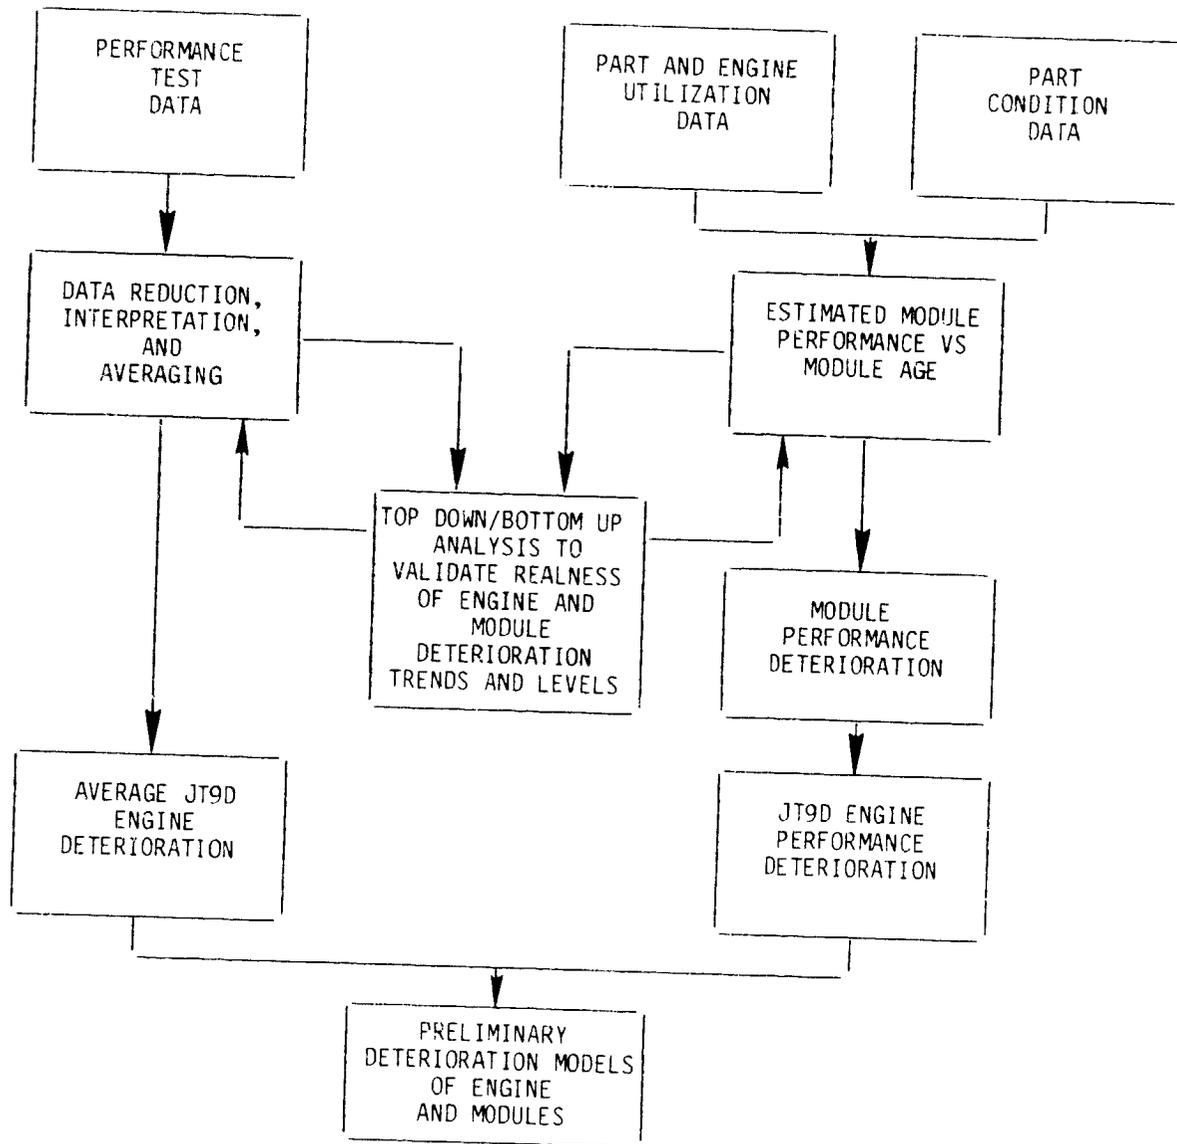
Figure 1 Technical Approach for Historical Data Collection and Analysis - The program was based on combining a "top down" and "bottom up" approach to enhance the data and validate the initial deterioration models.

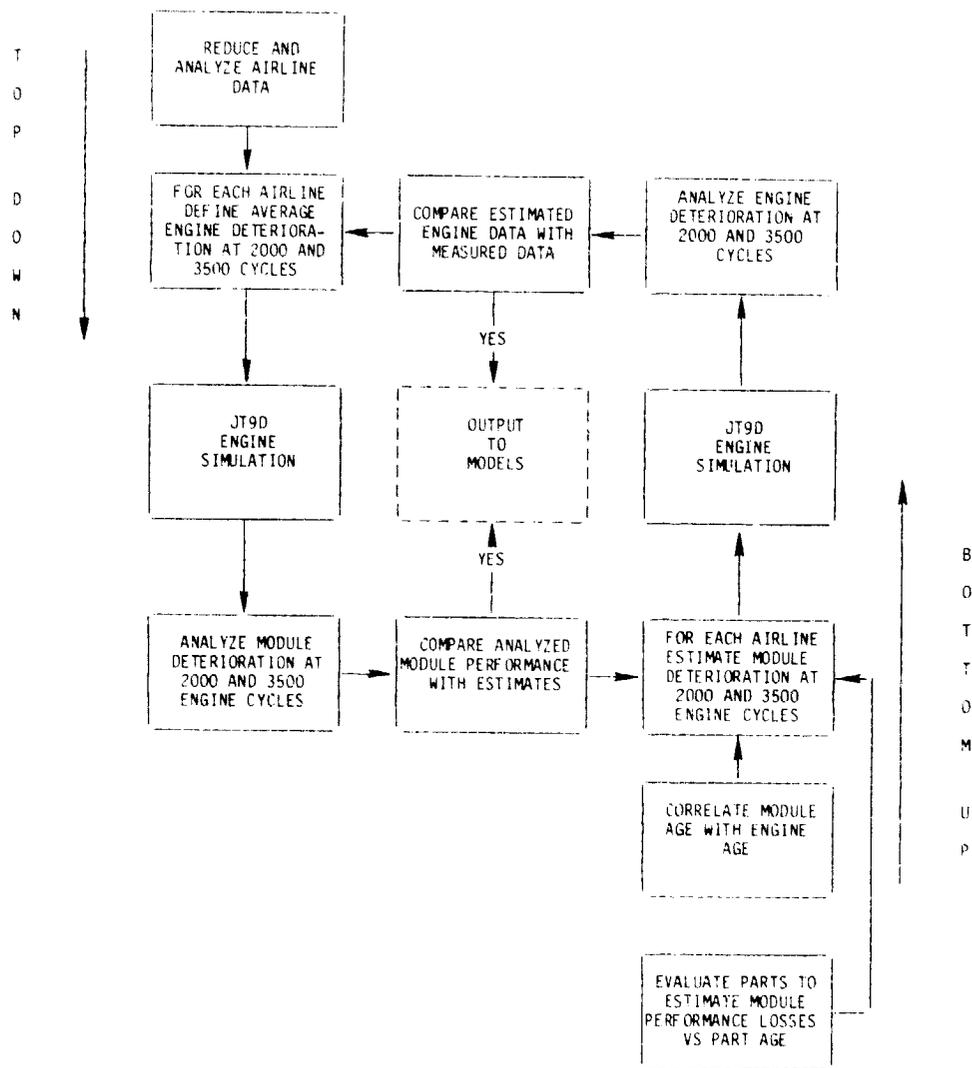
Figure 2 Engine Performance Deterioration Diagnostic Technique - A combination of top down and bottom up analysis utilizing the Pratt & Whitney Aircraft JT9D engine simulation permitted module performance deterioration to be modelled for an average JT9D engine in commercial service.

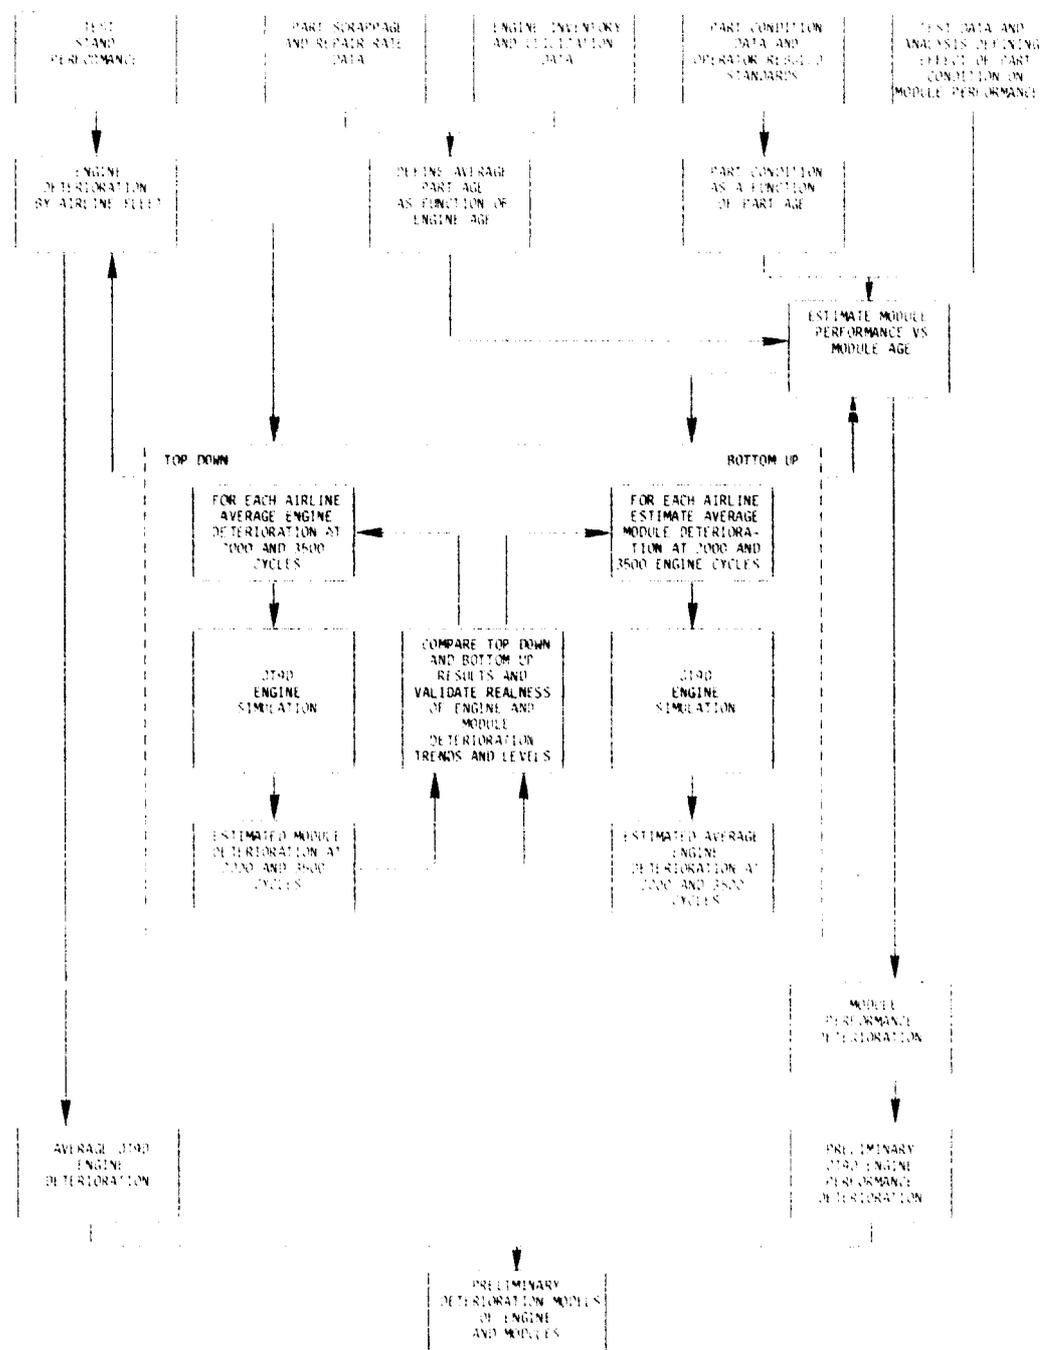
Figure 4 Overall Data Analysis Flow Chart - A "top down/bottom up" approach was used to correlate overall average engine data and the effects of deterioration of individual parts to model engine module deterioration as a function of engine flight cycles.

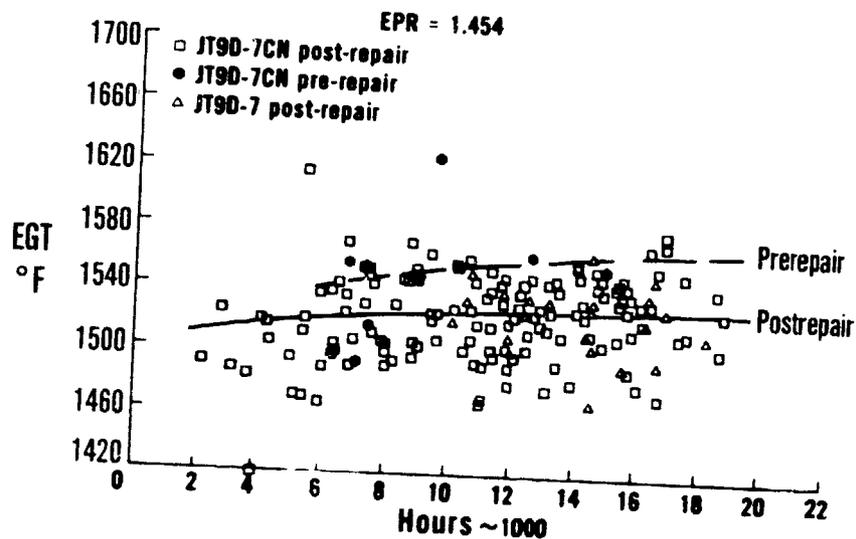
Figure 9 Absolute Exhaust Gas Temperatures (EGT) for Average Engine as a Function of Engine Age - Absolute values were established generally by plotting second-order least squares fits through the corrected data on an airline basis.

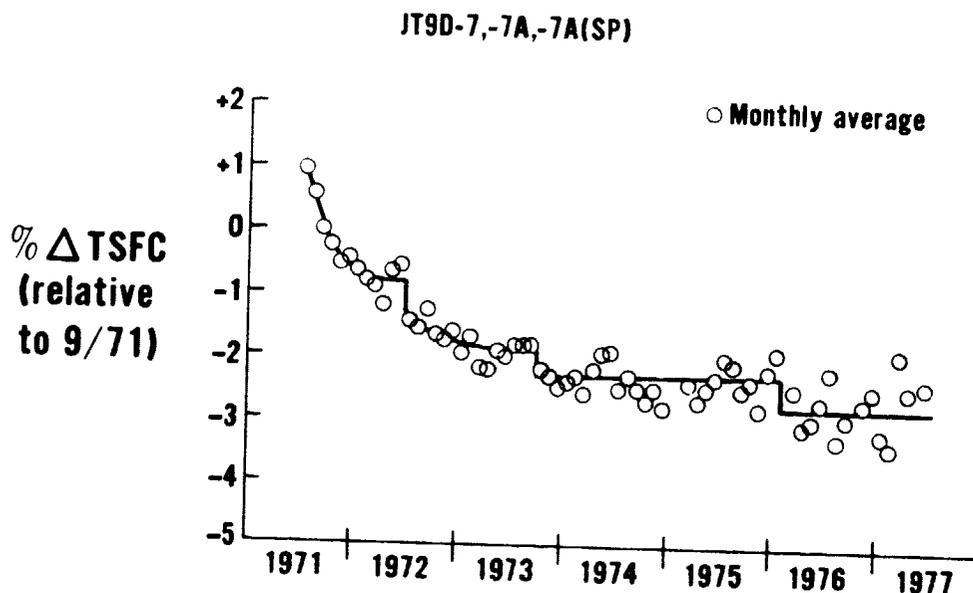
Figure 12 Production TSFC Levels at Take-off Thrust versus Time - The production TSFC trend shows the effect of various modifications incorporated in production engine take-off thrust TSFC levels at sea-level static conditions.

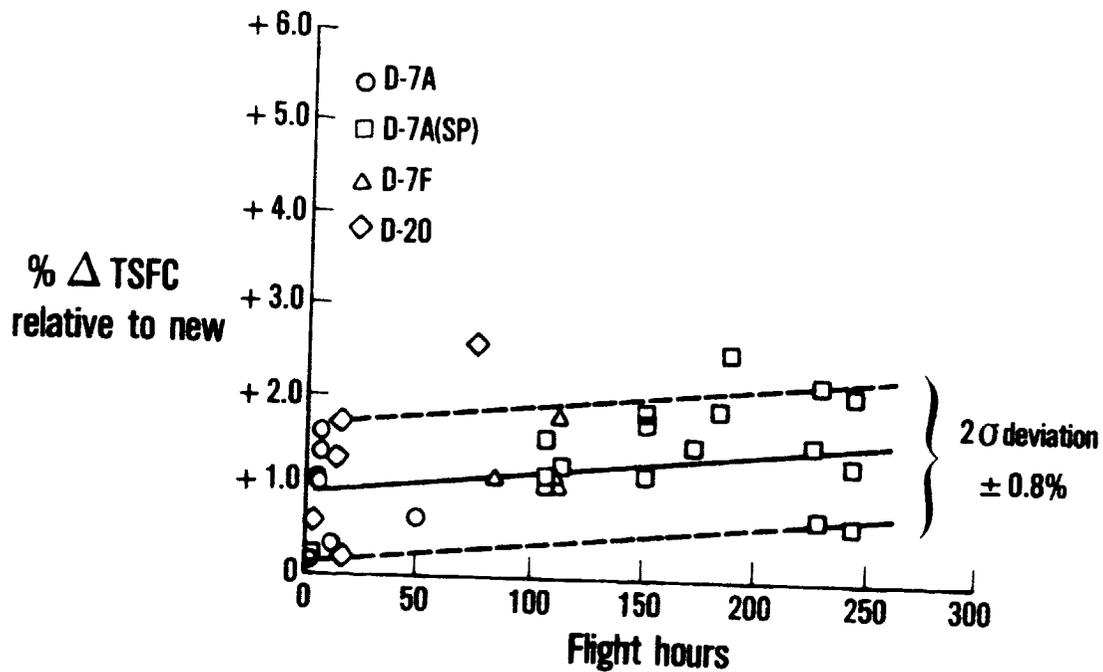
Figure 13 Short-Term TSFC Deterioration Trends as a Function of Flight Time - A significant loss in performance occurs very early followed by a more gradual, but continuing deterioration.

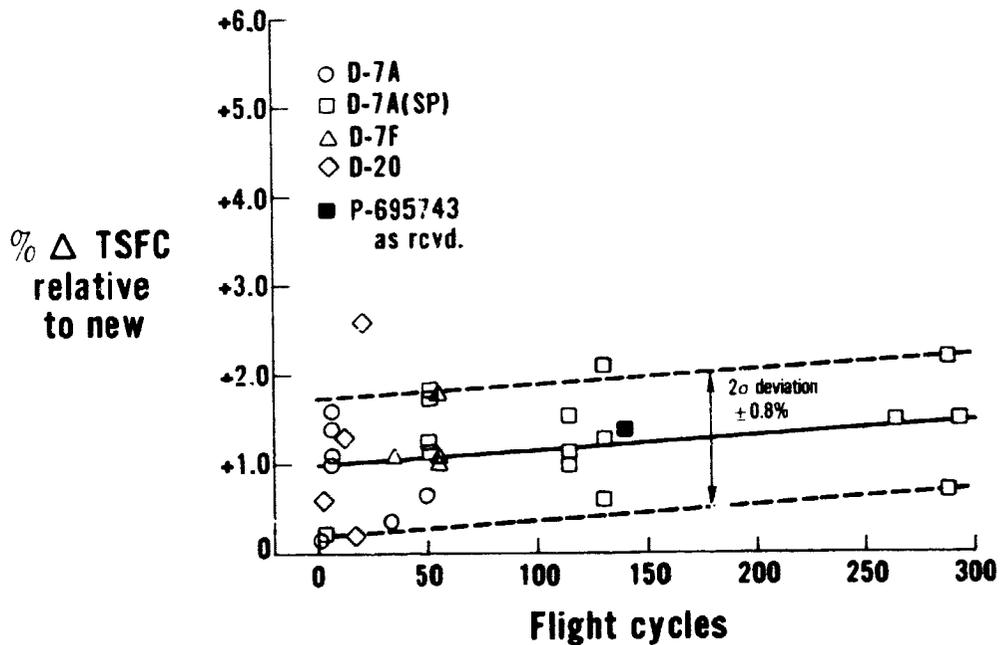
Figure 14 Short-Term TSFC Deterioration Trends as a Function of Flight Cycles - Short-term performance deterioration correlates better with flight cycles than flight time, indicating that this type of deterioration is probably related to structural loading.

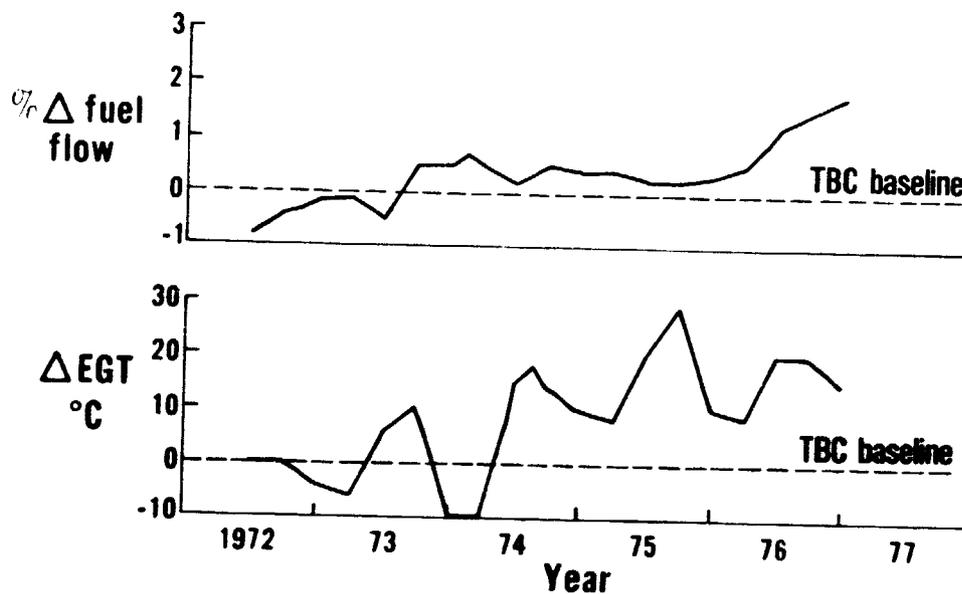
Figure 15 Fleet Deterioration for Pan American World Airways - Pan American engines exhibited gradual, continuing deterioration in fuel consumption with relatively large variations in exhaust gas temperature.

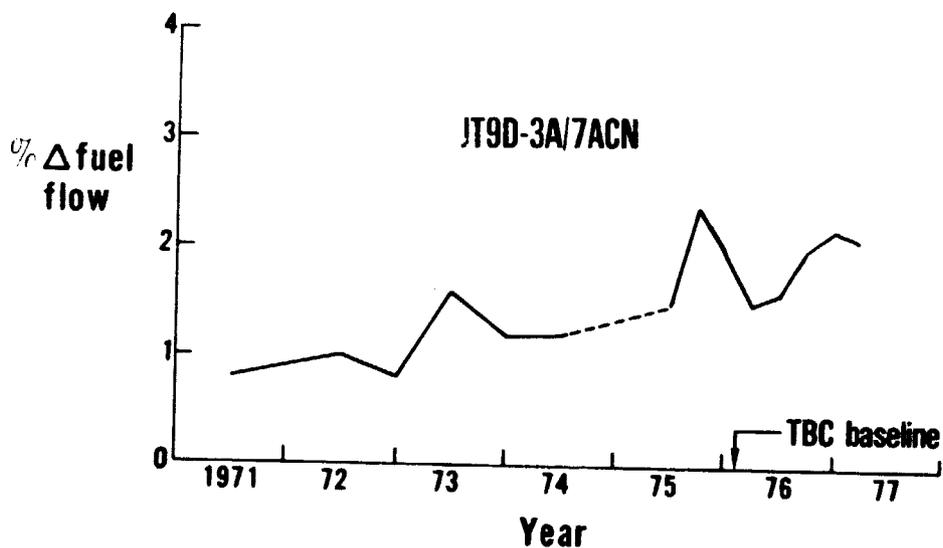
Figure 16 Fleet Deterioration for Trans World Airlines - Trans World Airlines experienced substantial variations in fuel consumption with a level higher than that of Pan American but a deterioration rate that was slower.

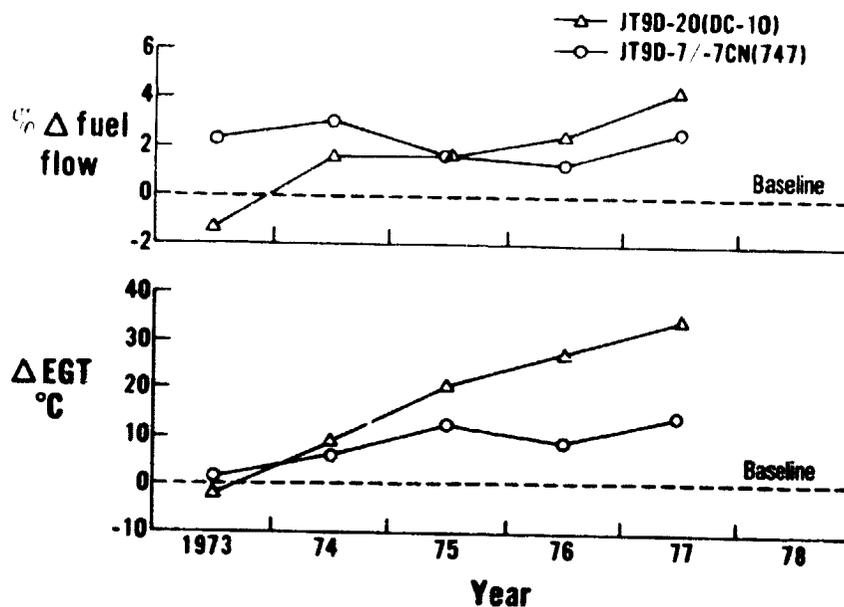
Figure 17 Fleet Deterioration for Northwest Airlines - The JT9D-2 trends are referenced to the Douglas DC-10 base line while the JT9D-7/7CN trends are referenced to the Boeing 747 base line.

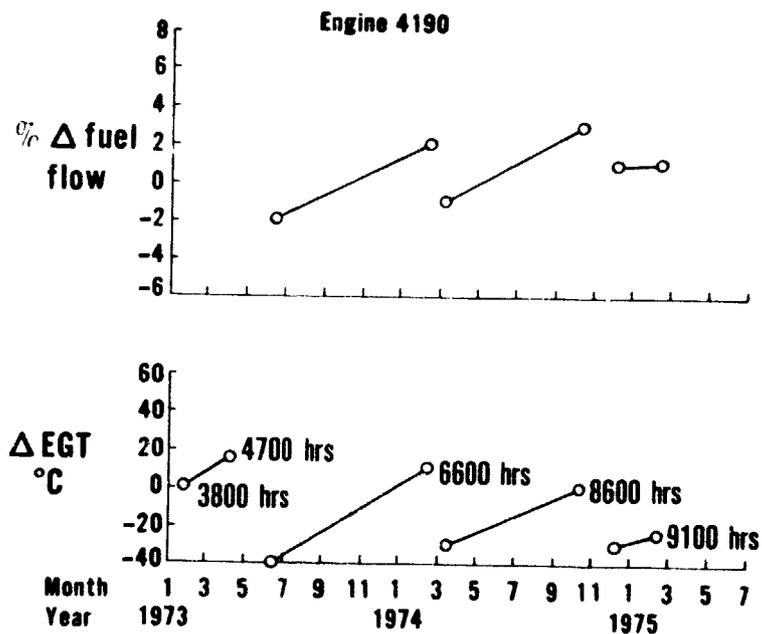
Figure 18 Cruise Engine Condition Monitoring Performance for Engine S/N 4190 - This engine demonstrated classical performance characteristics with a series of deterioration and recovery steps.

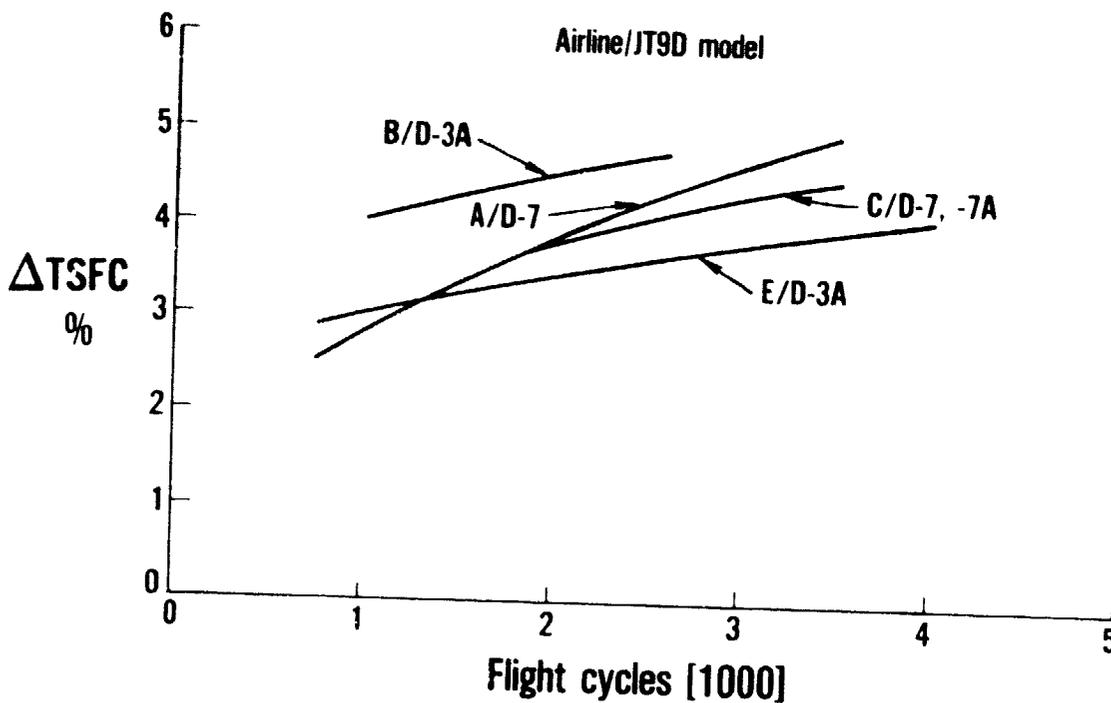
Figure 19 Prerepair TSFC Performance Deterioration at Take-Off Thrust for Individual Airline Engines Relative to New Engine Performance Levels - The data indicate significant variations among airline operators.

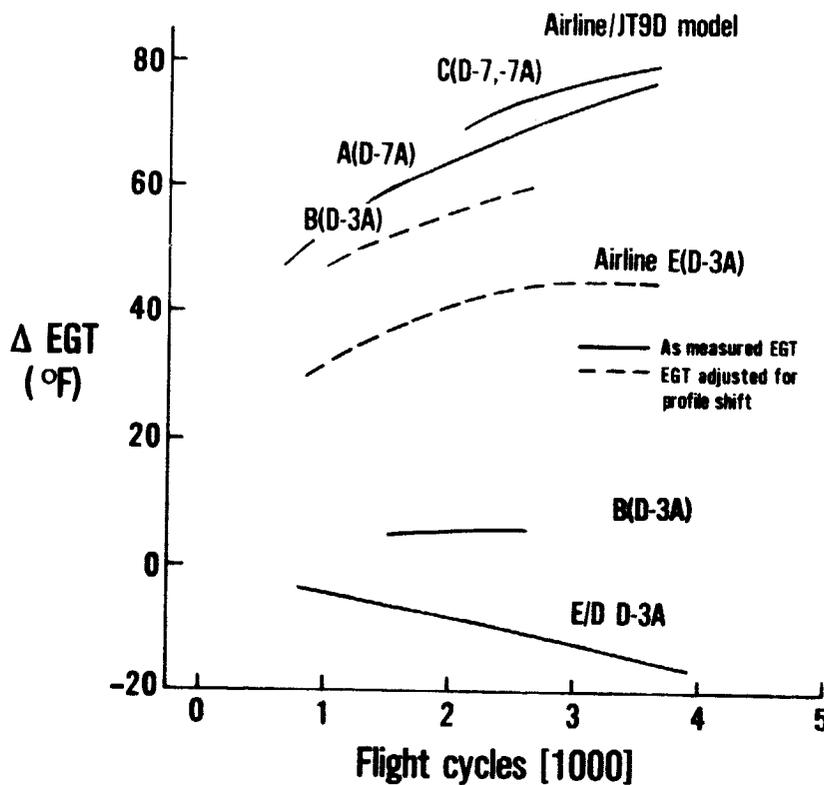
Figure 20 Prerepair EGT Performance Deterioration at Take-Off Thrust for Individual Airline Engines Relative to New Engine Performance Levels - The EGT data also shows large variations among airline operators.

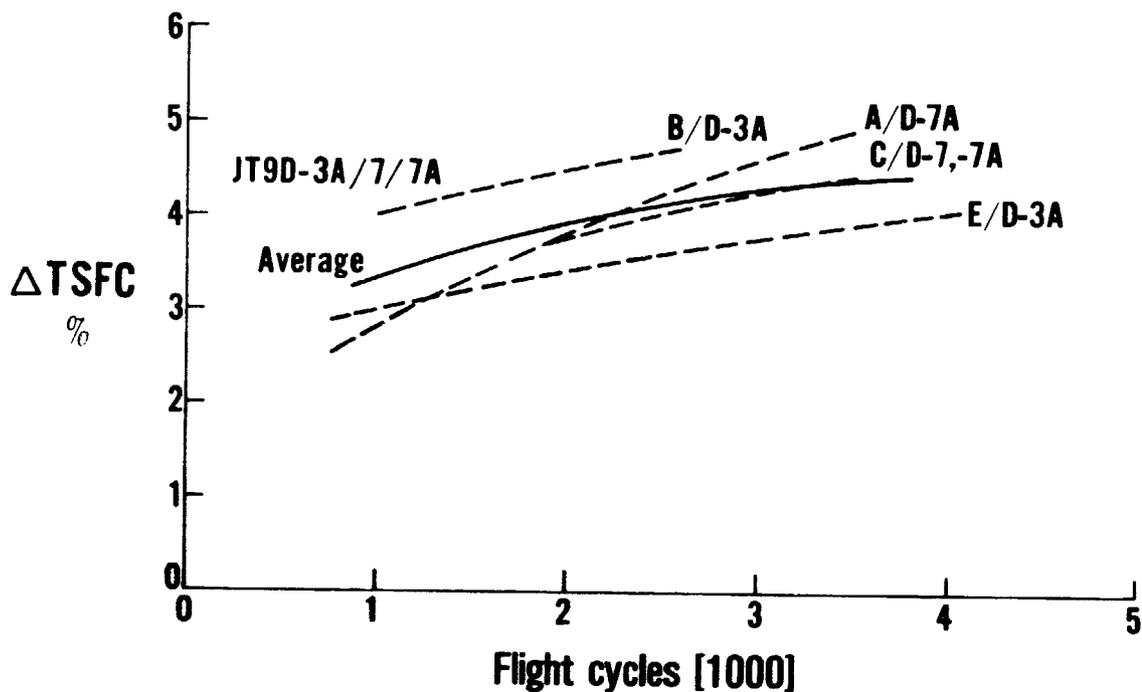
Figure 21 Average Fleet Prerepair TSFC Performance Deterioration at Take-Off Thrust Relative to New Engine Performance Levels - Average engine TSFC deterioration ranges from 3.2 to 4.4 percent between 1000 and 3500 flight cycles.

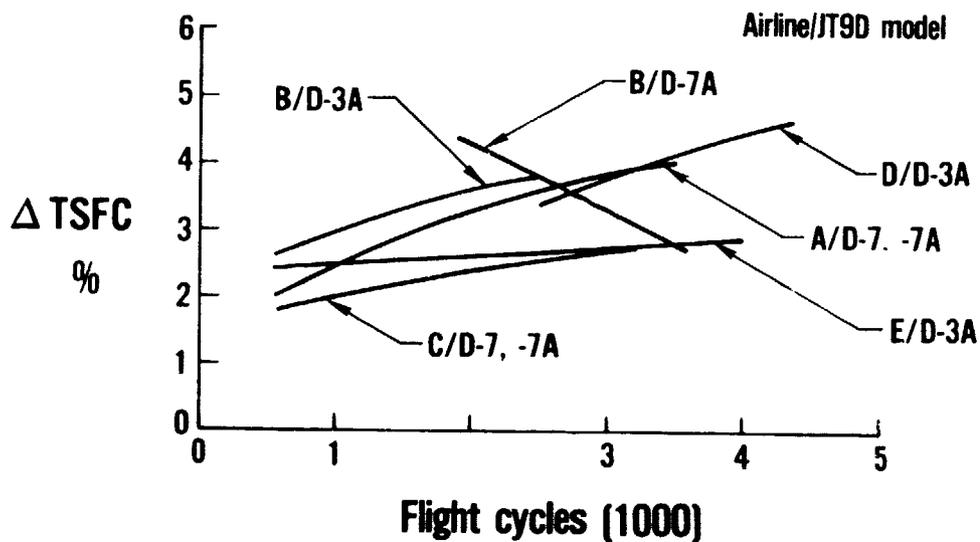
Figure 23 Postrepair TSFC Performance Deterioration at Take-Off Thrust for Individual Airline Engines Relative to New Engine Performance Levels - Similar to the prerepair data, the postrepair data indicate significant variations among airline operators, with one operator actually achieving an improvement in performance as a result of an extensive refurbishment program.

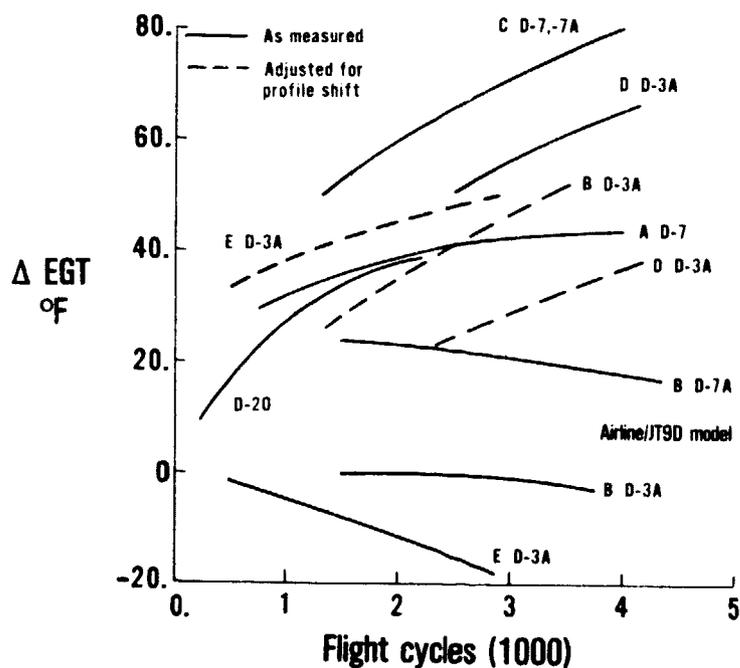
Figure 24 Postrepair EGT Performance Deterioration at Take-Off Thrust for Individual Airline Engines Relative to New Engine Performance Levels - Similar to the prerepair data, the postrepair data indicate significant variations among airline operators.

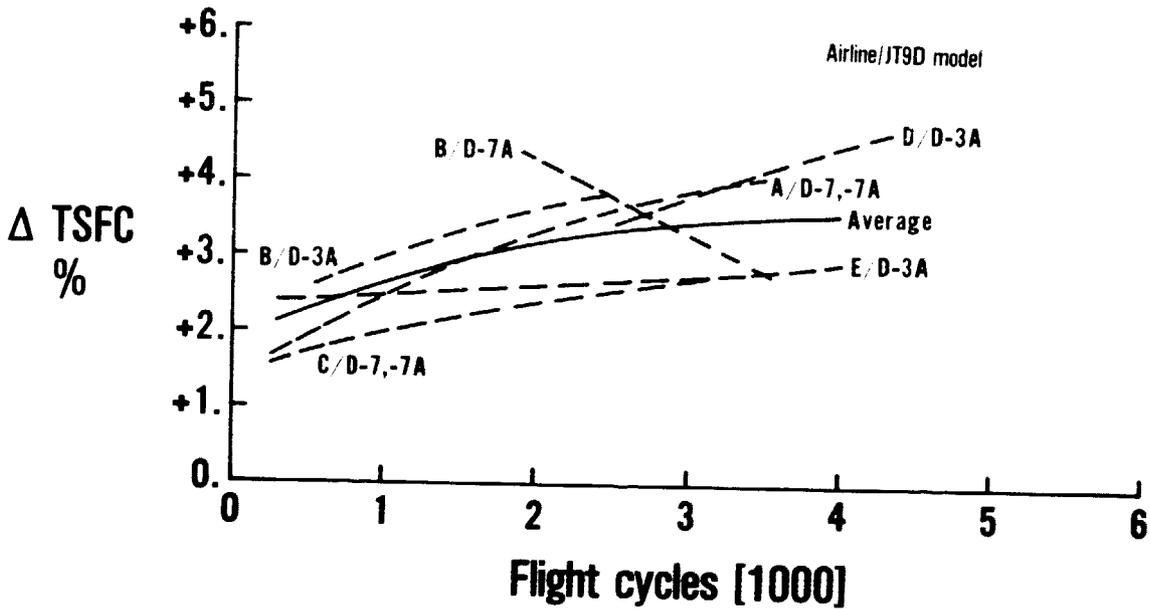
Figure 25 Average Fleet Postrepair TSFC Performance Deterioration at Take-Off Thrust Relative to New Engine Performance Levels - Average engine TSFC deterioration following repair ranges from 2.1 to 3.6 percent.

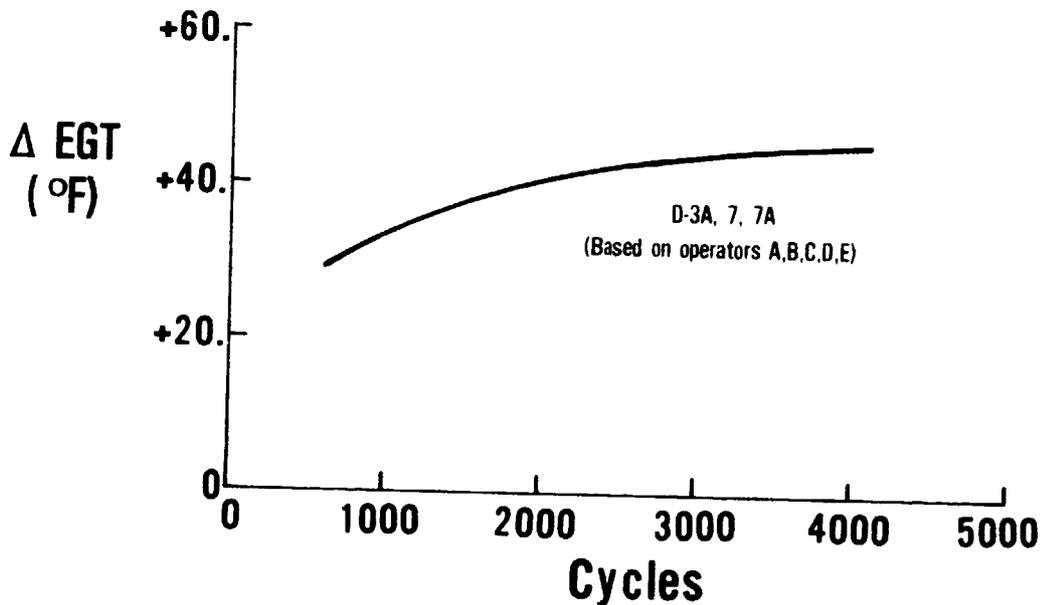
Figure 26 Average Fleet Postrepair EGT Performance Deterioration at Take-Off Thrust Relative to New Engine Performance Levels - Average temperature increases up to 40°F are experienced by high-time JT9D engines following repair.

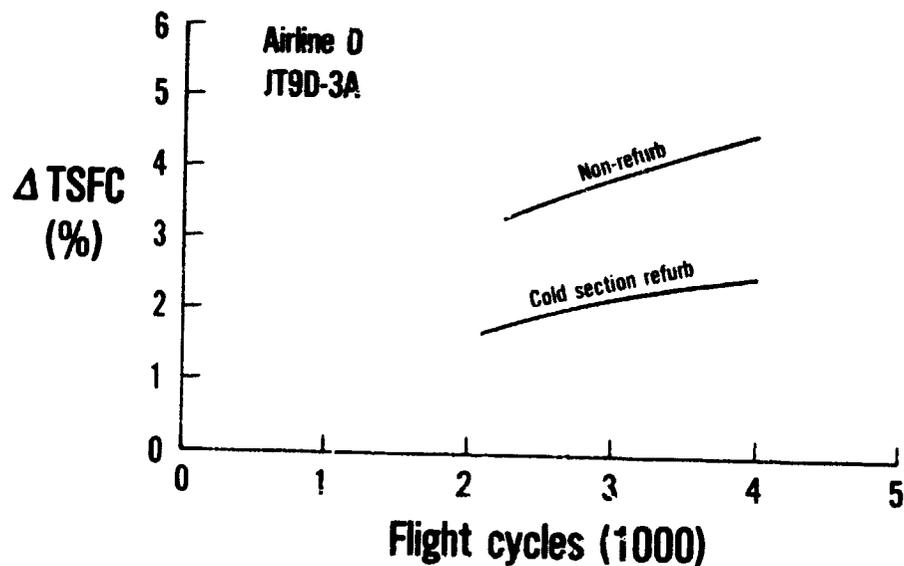
Figure 28 Effect of Cold-Section Refurbishment on TSFC - Airline D demonstrated a 2.2 percent recovery in TSFC through cold-section refurbishment. The changes in TSFC are all shown relative to new production engines performance levels.

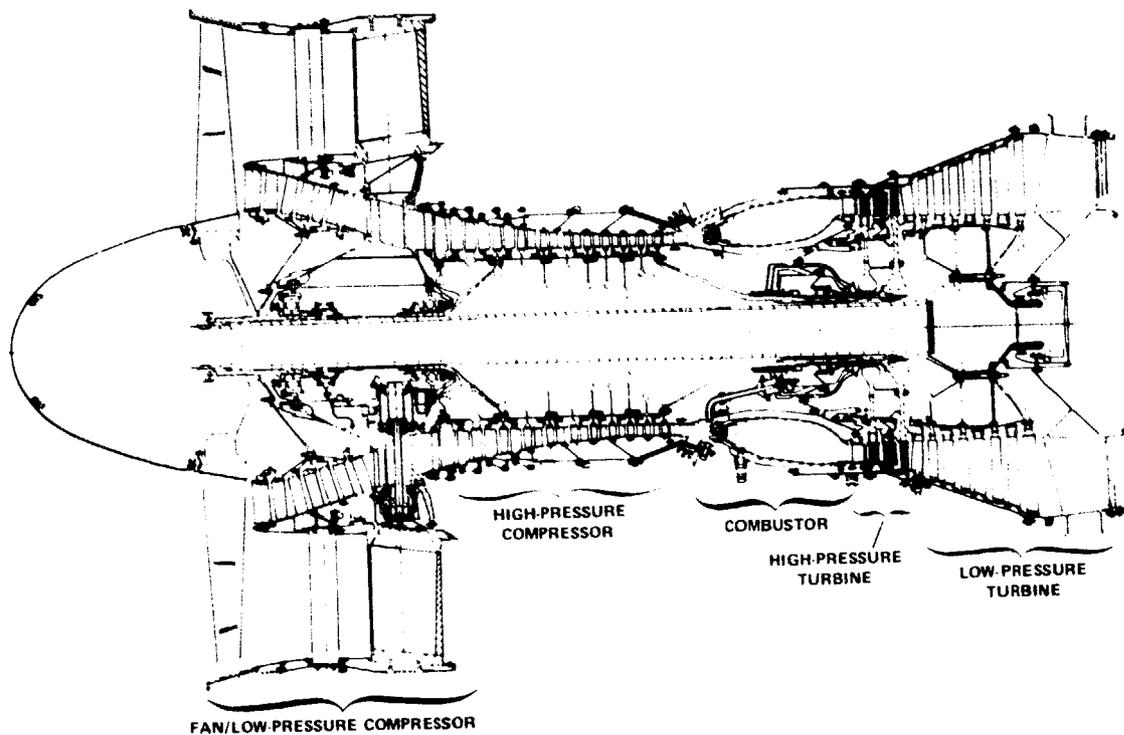
Figure 29 JT9D Engine Cross Section - The modules identified correspond to the breakdown used for module performance deterioration analysis.

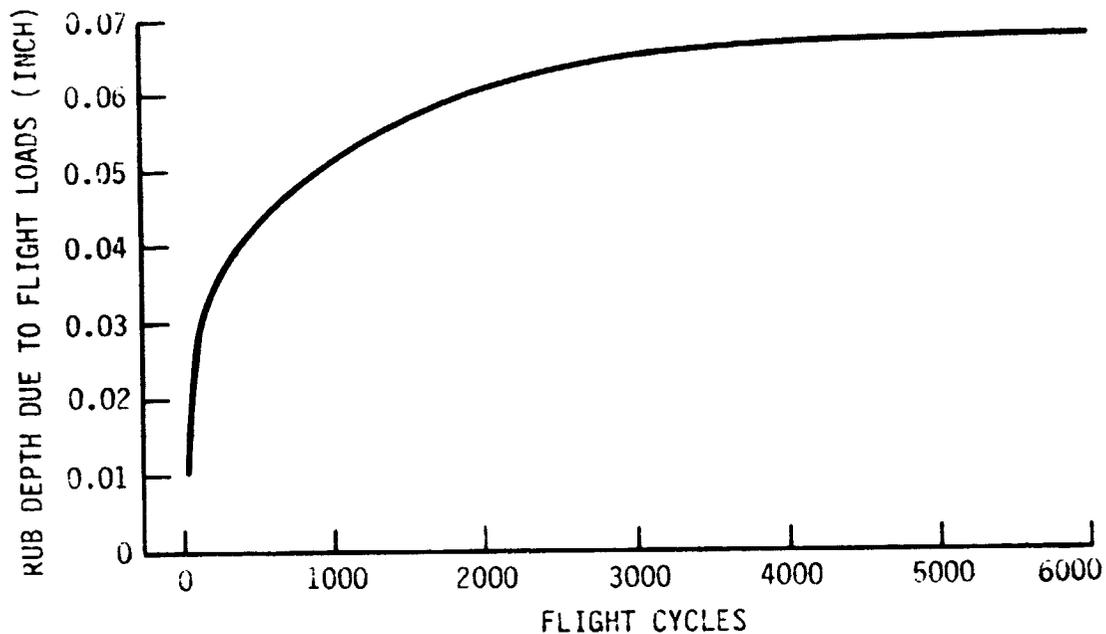
Figure 32 Predicted Fan Clearance Changes from Analytical Studies of the Effects of Flight Loads on Performance Deterioration - The clearance changes are predicted to occur most rapidly within the first 1000 flights.

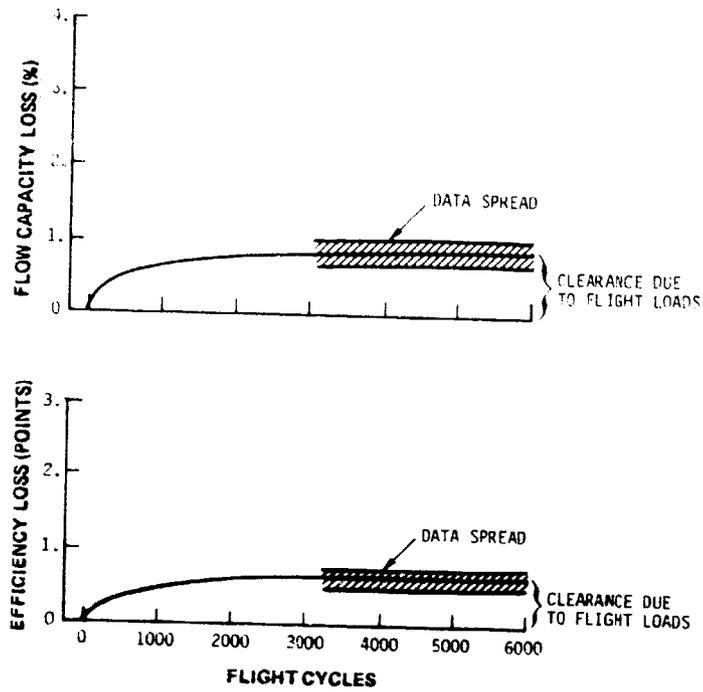
Figure 34 Effect of Clearance Changes on Fan Flow Capacity and Efficiency - Changes in flow capacity and efficiency were predicted based on the observed condition of service parts.

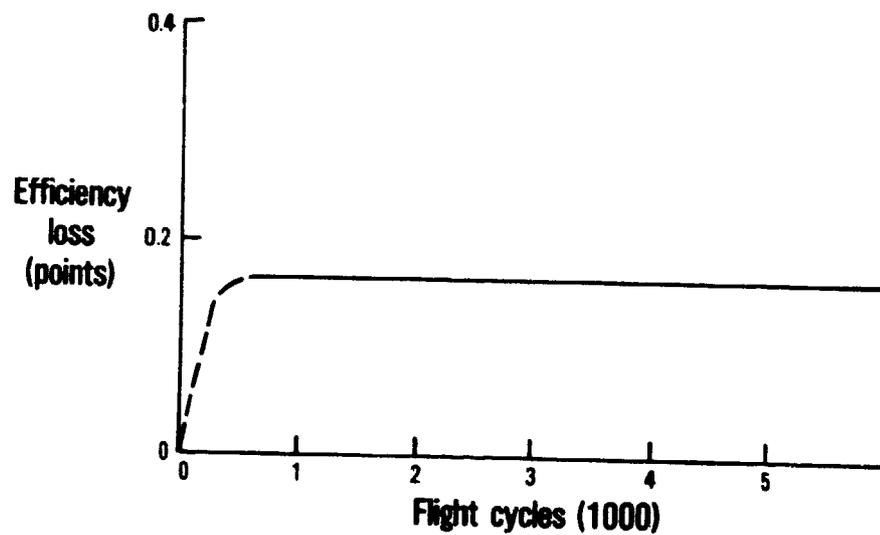
Figure 35 Effect of Surface Roughness on Fan Efficiency - Predictions based on observed parts condition indicate that surface roughness produces a small change in fan efficiency.

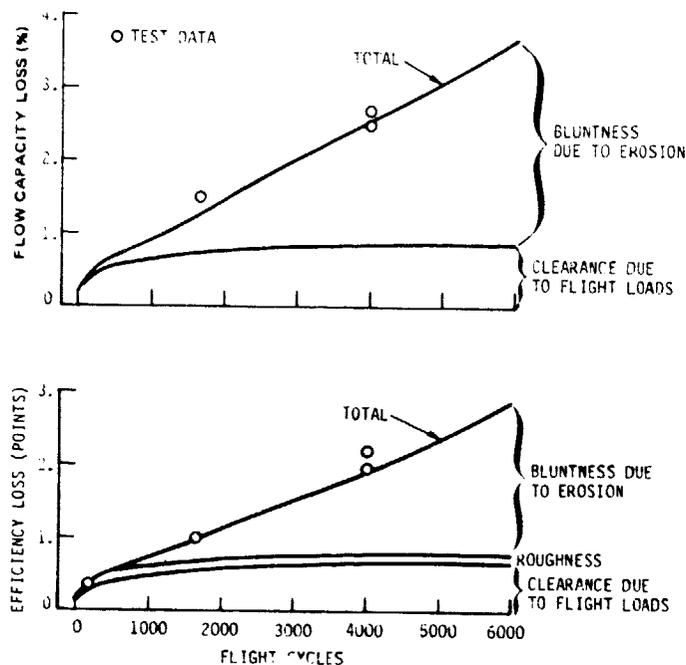
Figure 36 Back-to-Back Fan Test Data - The data establishes the level of deterioration being experienced by the average fan module.

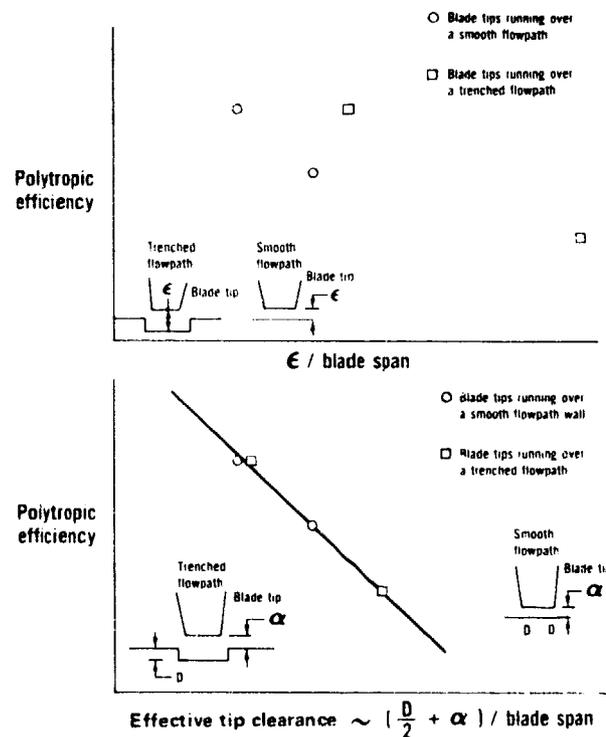
Figure 38 Effect of Trenching on Performance Losses Associated with Blade Tip Clearance - Test data shows that the clearance in the trench produces one-half the loss associated with the clearance in the mainstream.

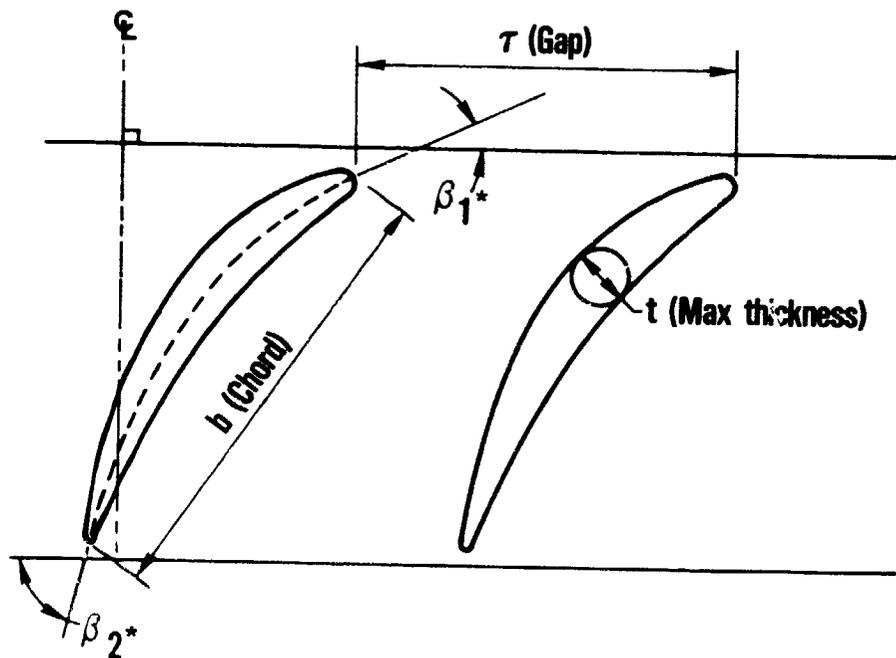
Figure 40 Nomenclature for Airfoil Parameters - The parameters shown are the significant parameters with respect to the effects of erosion on airfoil performance.

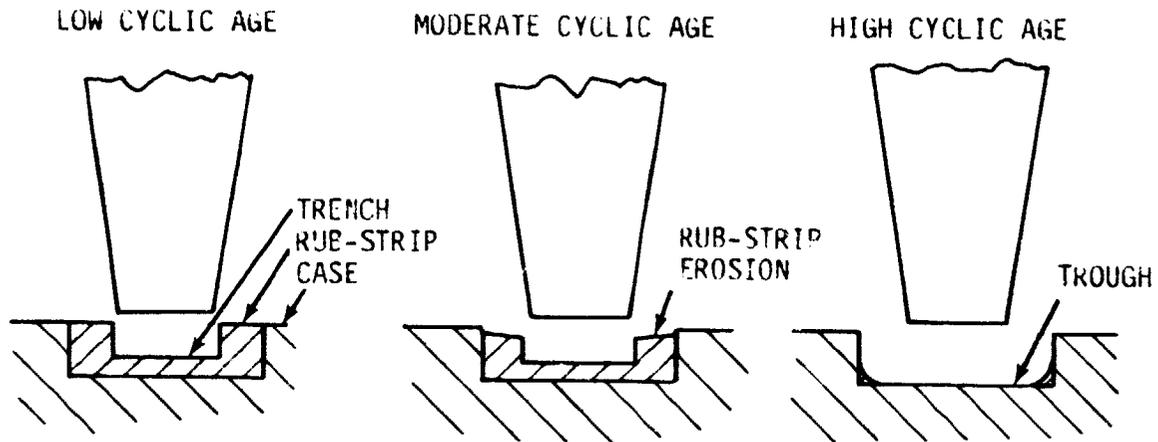
Figure 42 Schematic of Low-Pressure Compressor Tip Clearance Wear Mechanisms - Trenching occurs early followed by erosion of the rub strip until it is virtually eroded away.

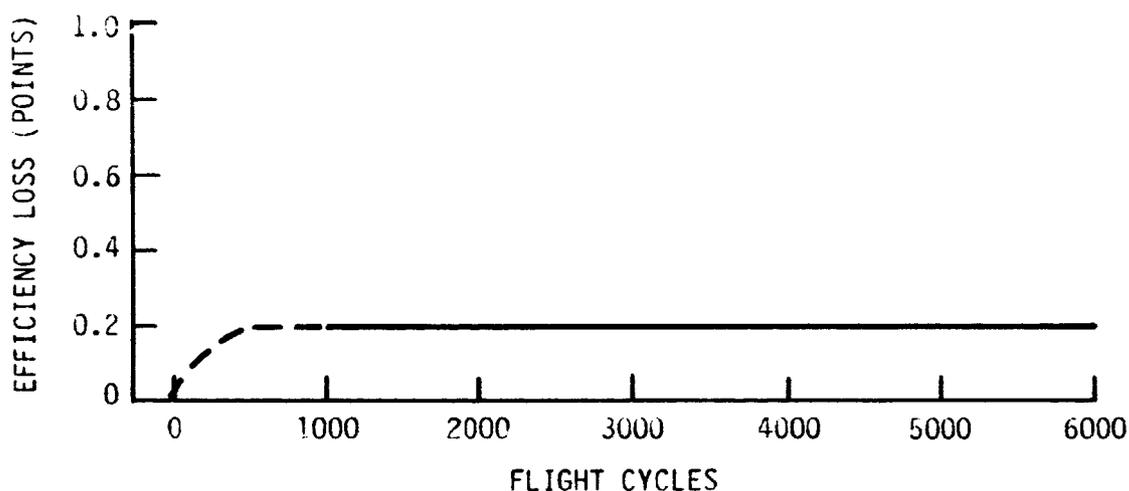
Figure 50 Effect of Low-Pressure Compressor Airfoil Surface Roughness on Efficiency - The increase in surface roughness causes a loss of 0.2 percentage point in low-pressure compressor efficiency.

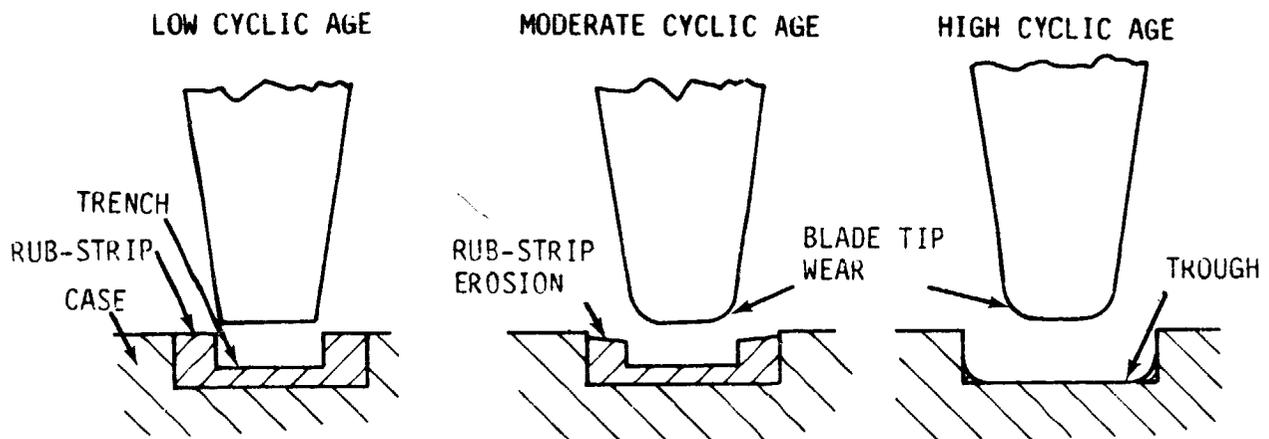
Figure 54 Schematic of Tip Clearance Wear Mechanism for High-Pressure Compressor - Erosion and trenching occur early in the compressor life, but continued usage results in erosion that virtually eliminates all evidence of trenching.

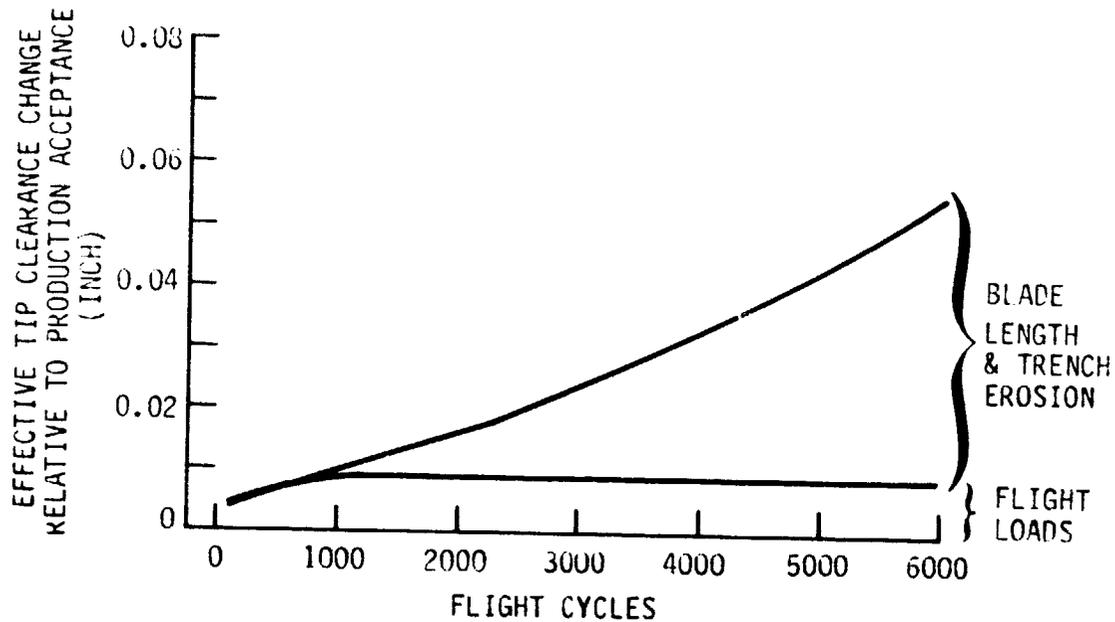
Figure 58 Effective Tip Clearance Increases Relative to Production Acceptance - Blade length loss and trench erosion are the major causes for clearance changes.

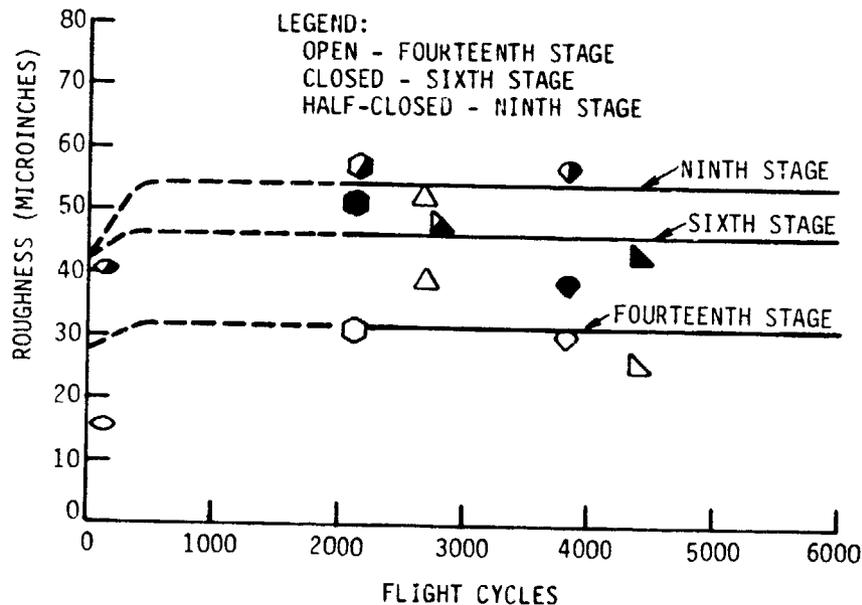
Figure 60 Surface Roughness Data for JT9D Sixth-, Ninth-, and Fourteenth-Stage Blades - Surface roughness increases slightly during the first 500 cycles and then remains constant.

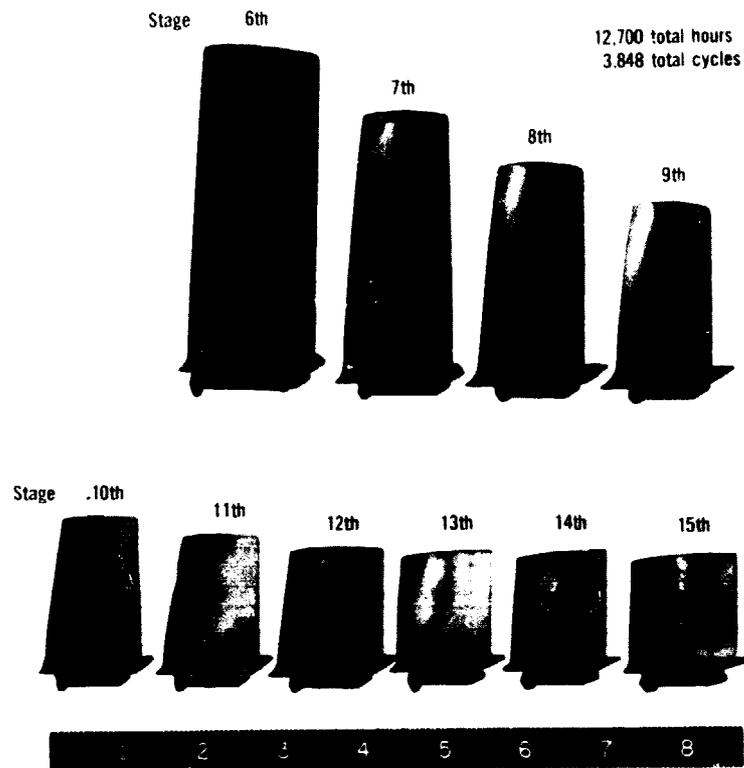
Figure 64 JT9D High-Pressure Compressor Blades with High Hourly Usage but Moderate Cycle Usage - These blades show relatively little wear.
